Walk Around

Fw 190D

By E. Brown Ryle and Malcolm Laing

Focke-Wulf Fw 190D-9

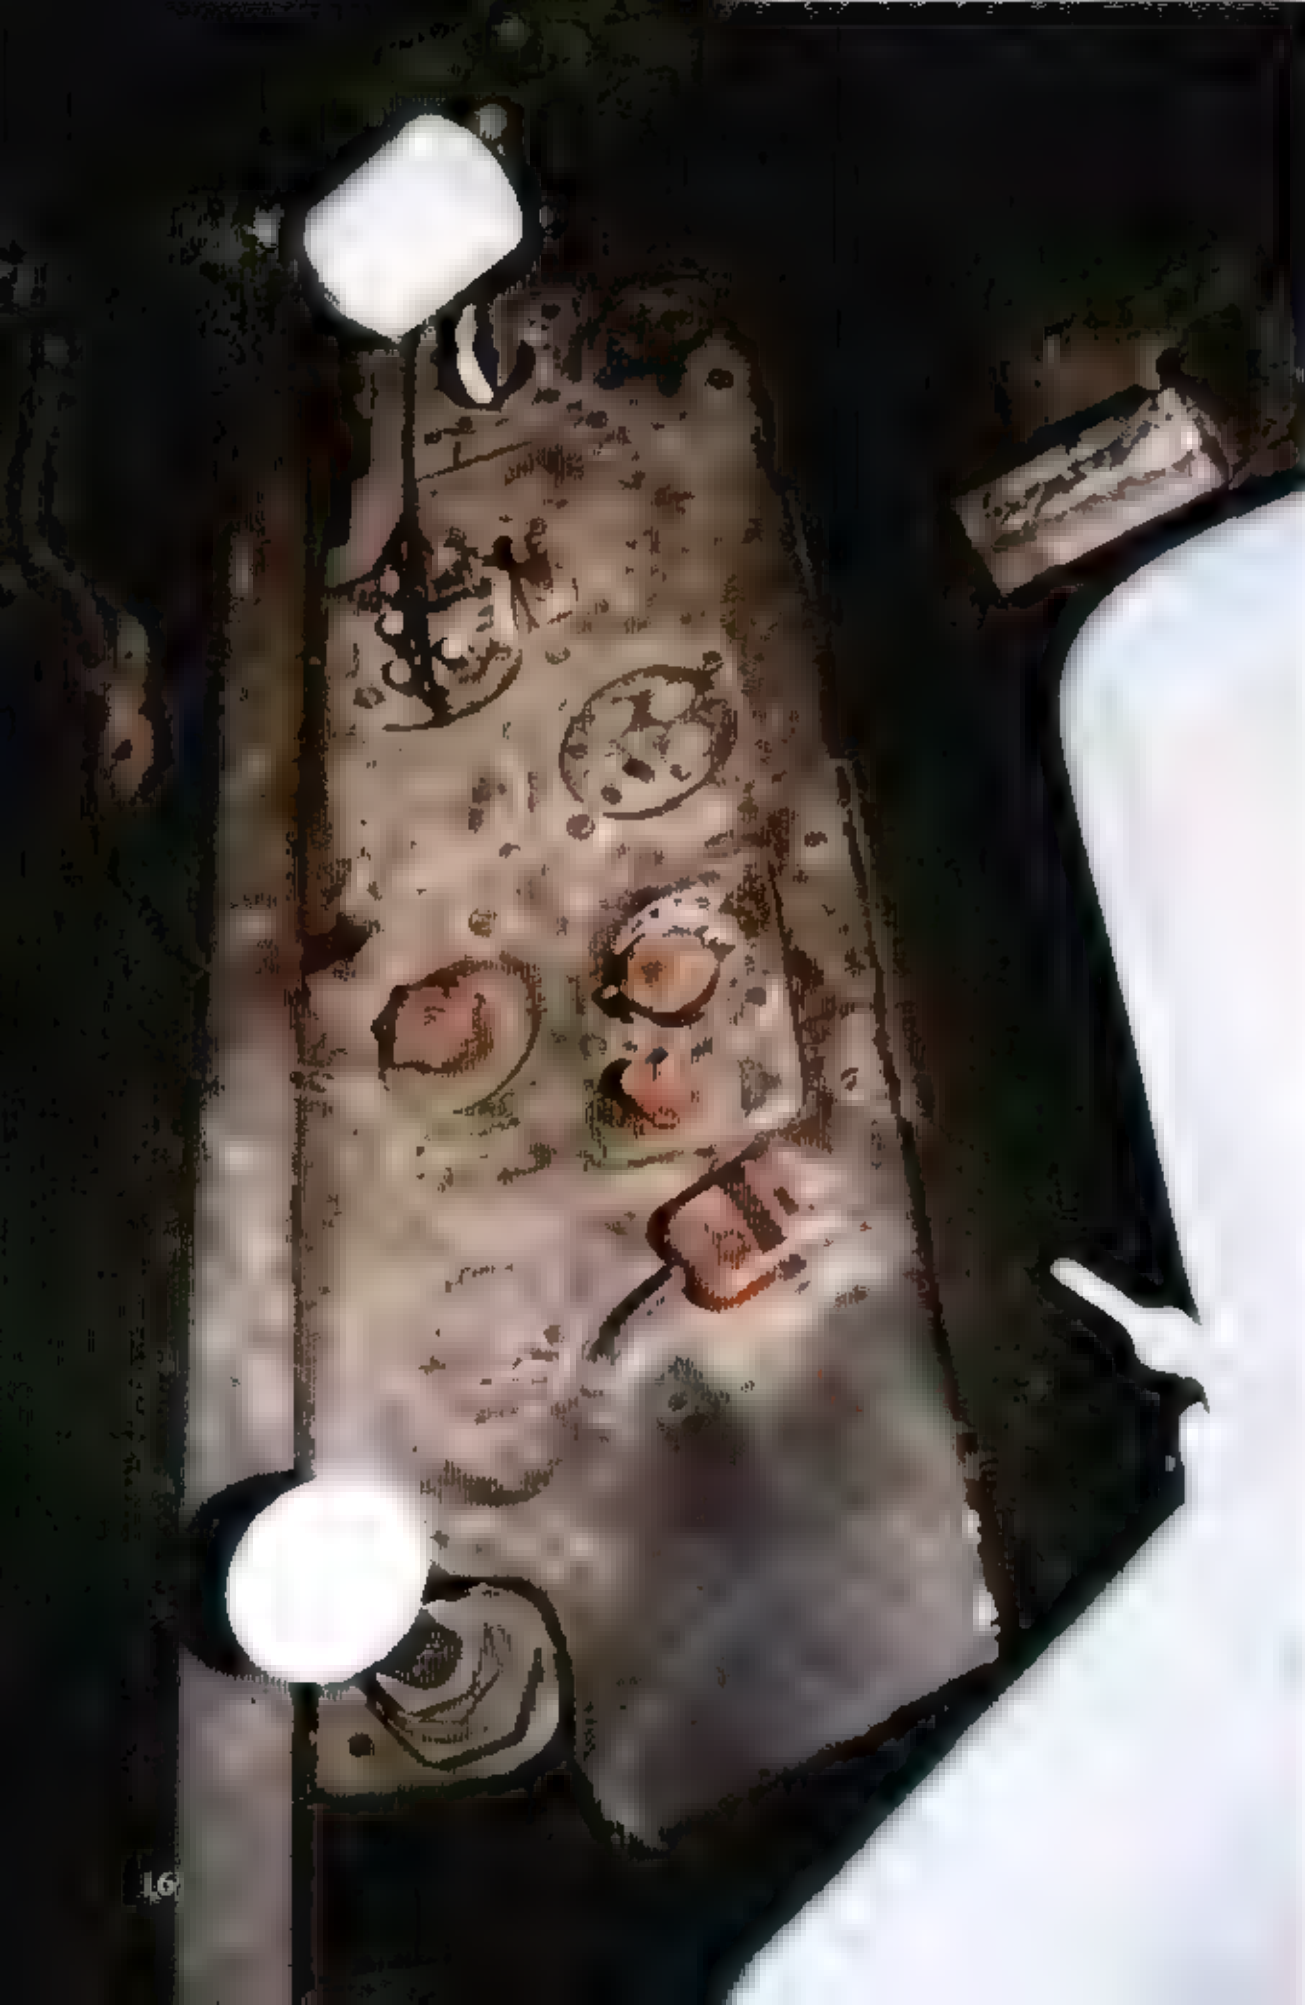
(Above) Forward of the throttle lever is the trim indicator, starter button, and the instrument light dimmer. On the lower instrument panel is the IFF panel, above that is the landing gear manual extension and the red knobbed handle is the manual fuel tank selector lever. (Author: Ryle)

(Left) The left console, like the right, is dusty, but original. The white knobbed plunger at the rear of the console is the primer fuel pump handle. The Brown plug-in forward of the primer is for the pilot's headset. The two turn knobs are controls for the FuG 16ZY radio. Further forward are the landing gear and flap actuator buttons with the horizontal stabilizer trim switch to their right. The large white knob is on the throttle lever. (Author: Ryle)

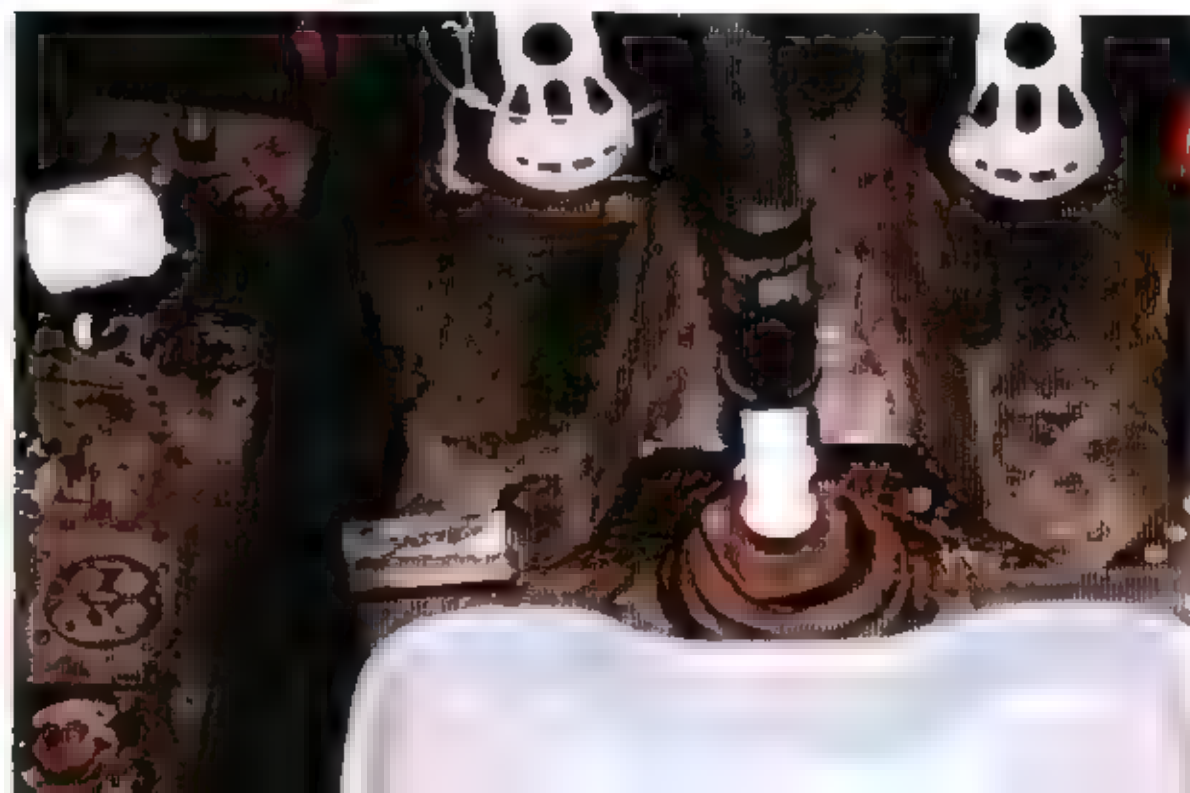
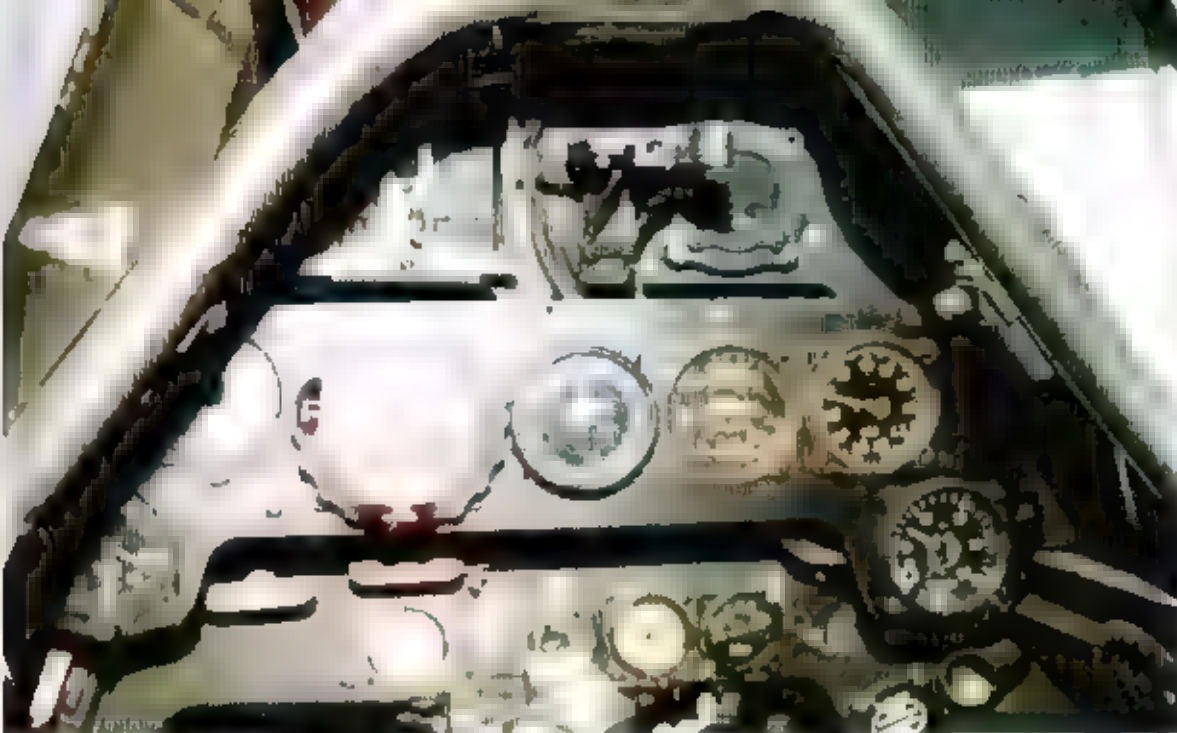
(Above) The upper and lower instrument panels are surrounded by a leather cushioned combing. On the upper left, just under the combing, are the ammunition counters (which are missing) and to the right of the counters is the Revi 16 gun sight (not installed) mount. To the right of the mount is the AFN 2 homing indicator used for instrument approaches. (Author: Rylie)

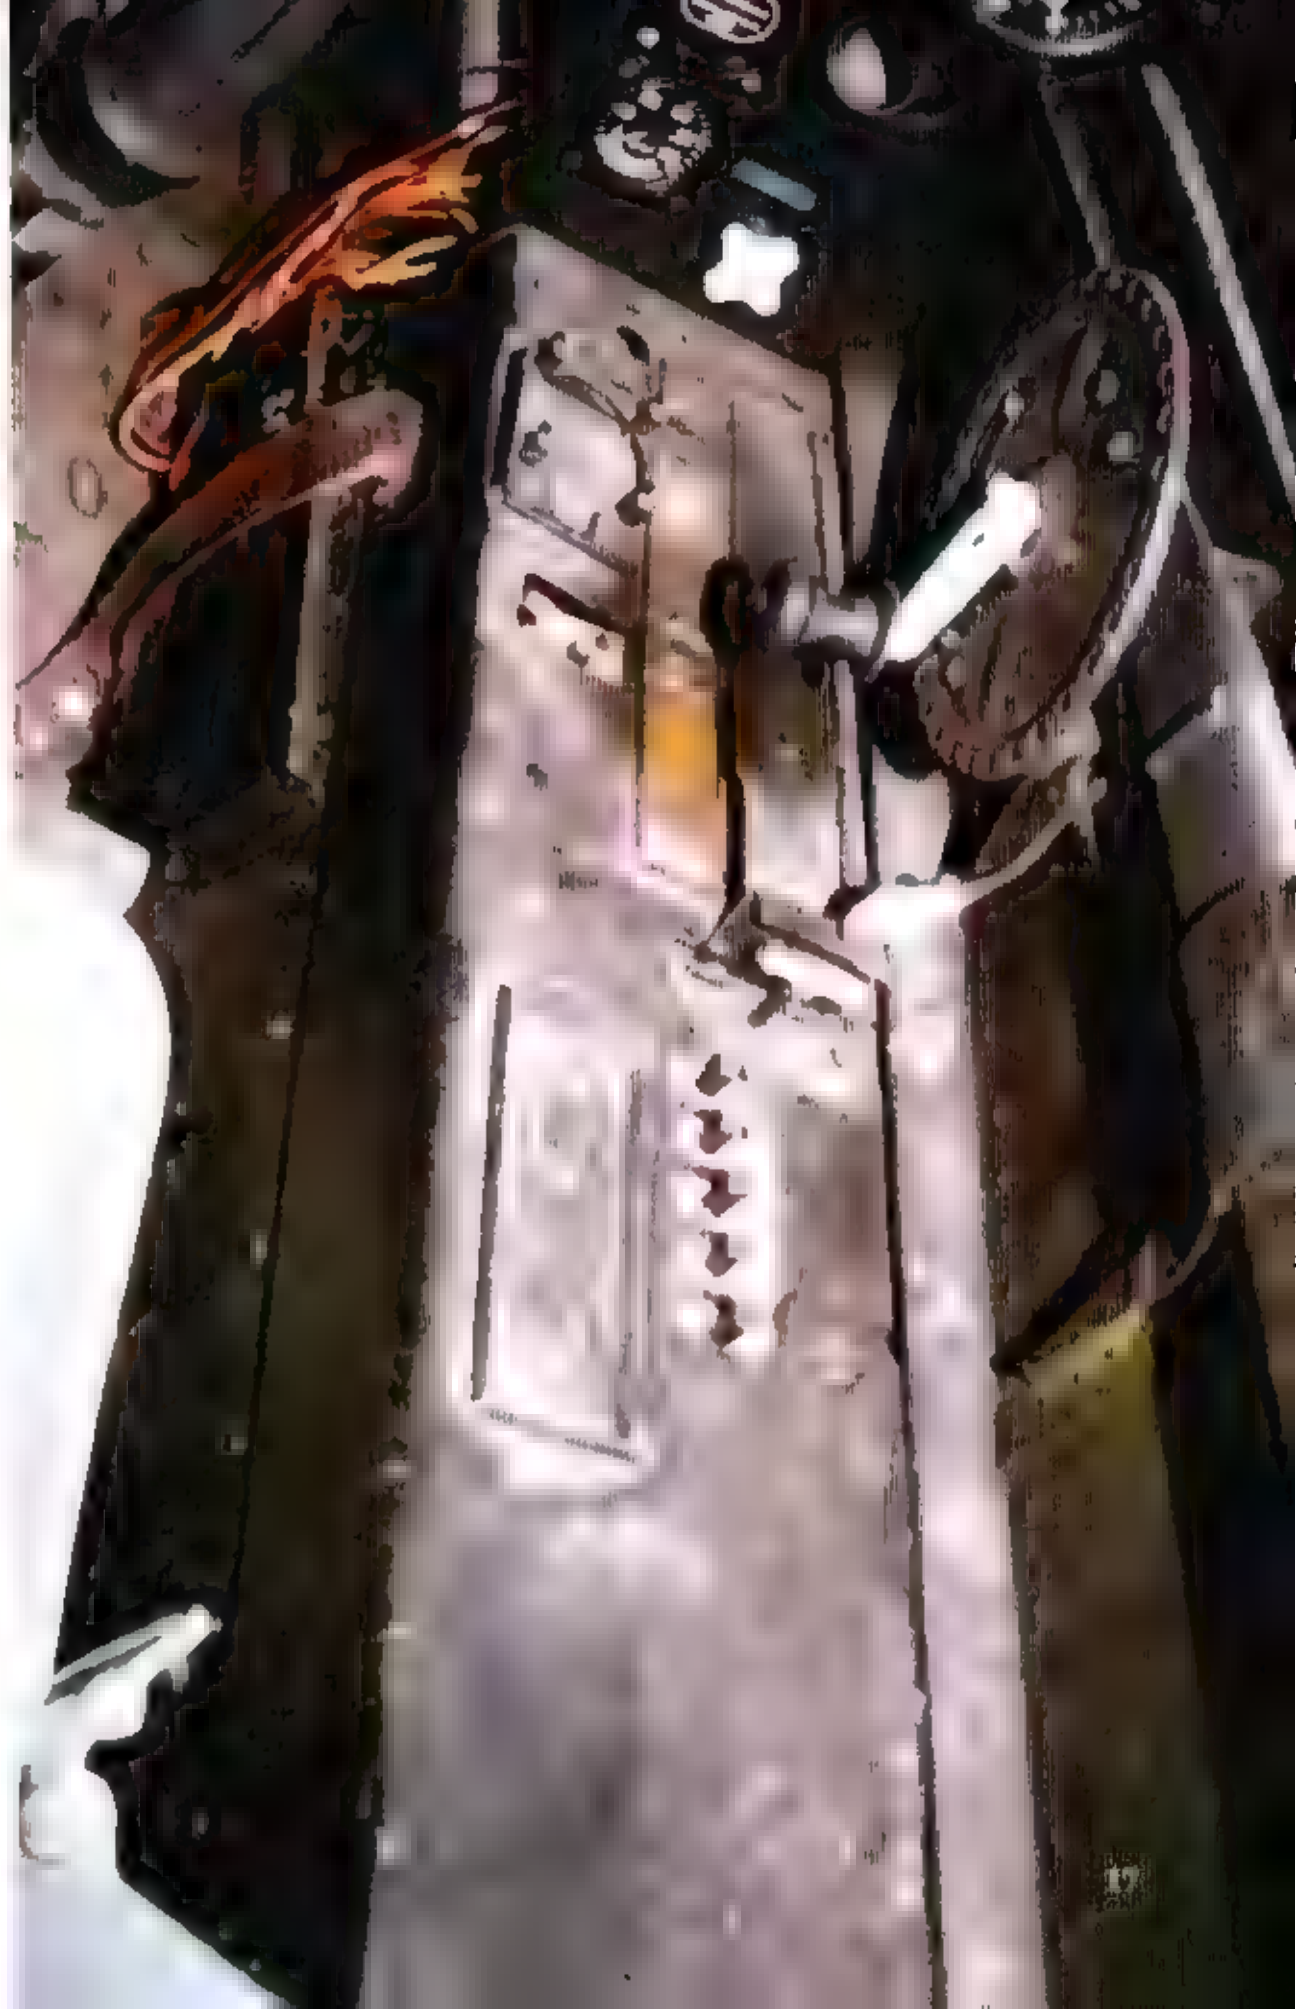
(Below) The forward right section of the Fw 190D-9 cockpit. The differences in the upper and the lower recessed instrument panel are well defined. On the right side of the lower instrument panel is the flare tube and the oxygen instrument group. The missing instrument on the lower panel just below and to the right of the flare chute is a clock (Author: Rylie)

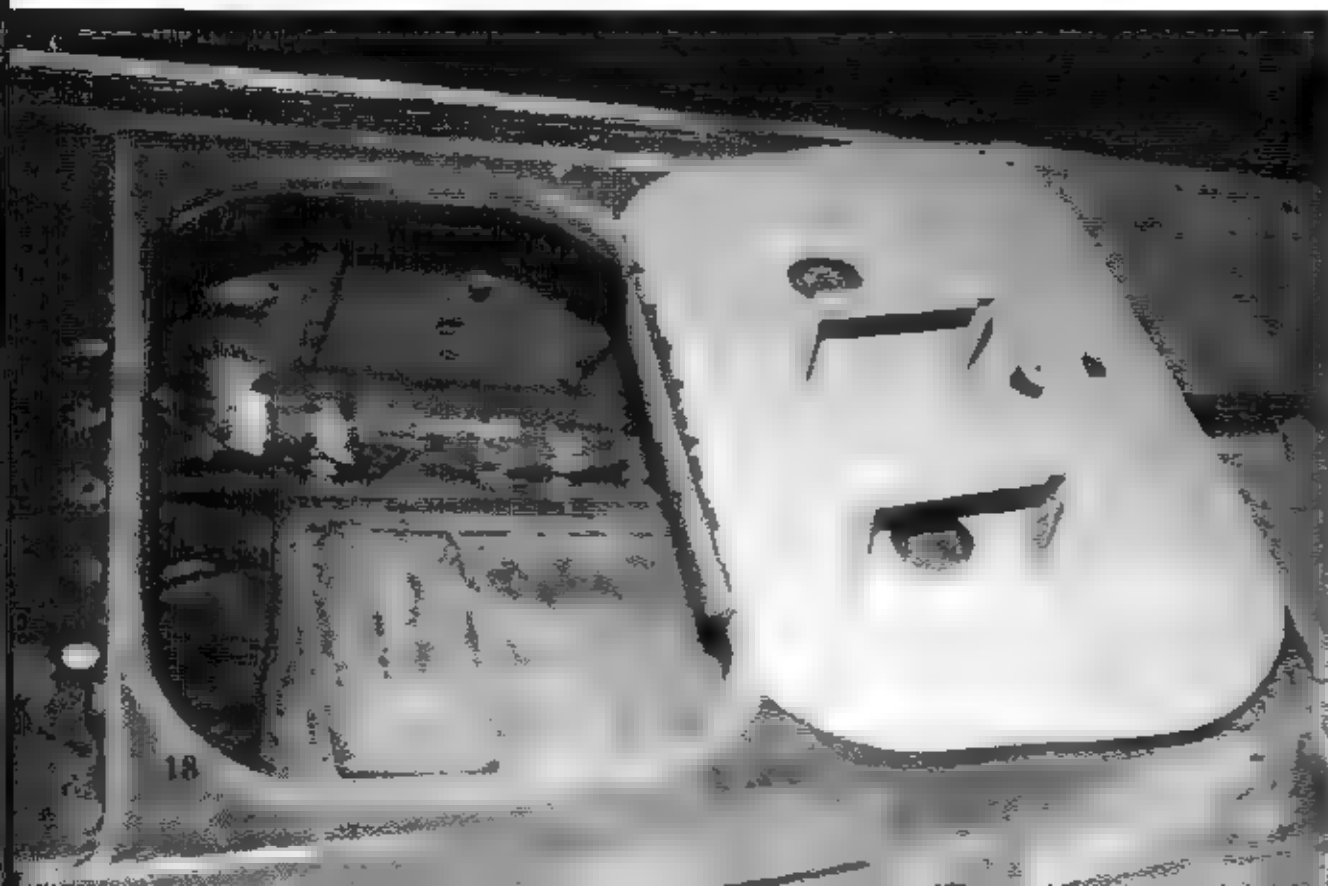
The seat was positioned at the very rear of the cockpit against the rear wall. The shelf built into the back supported the pilot's parachute. The white button to the right of the seat is the oxygen regulator. The canopy slide track can be seen above the seat. (Author: Ryle)

The shoulder strap attachment bars are bolted and riveled to the lower face of the shoulder armor plate just above the seat back. Both of these attachment bars face to the left, it is not known if this procedure was intentional, accidental, or due to wartime conditions (Author: Ryle)

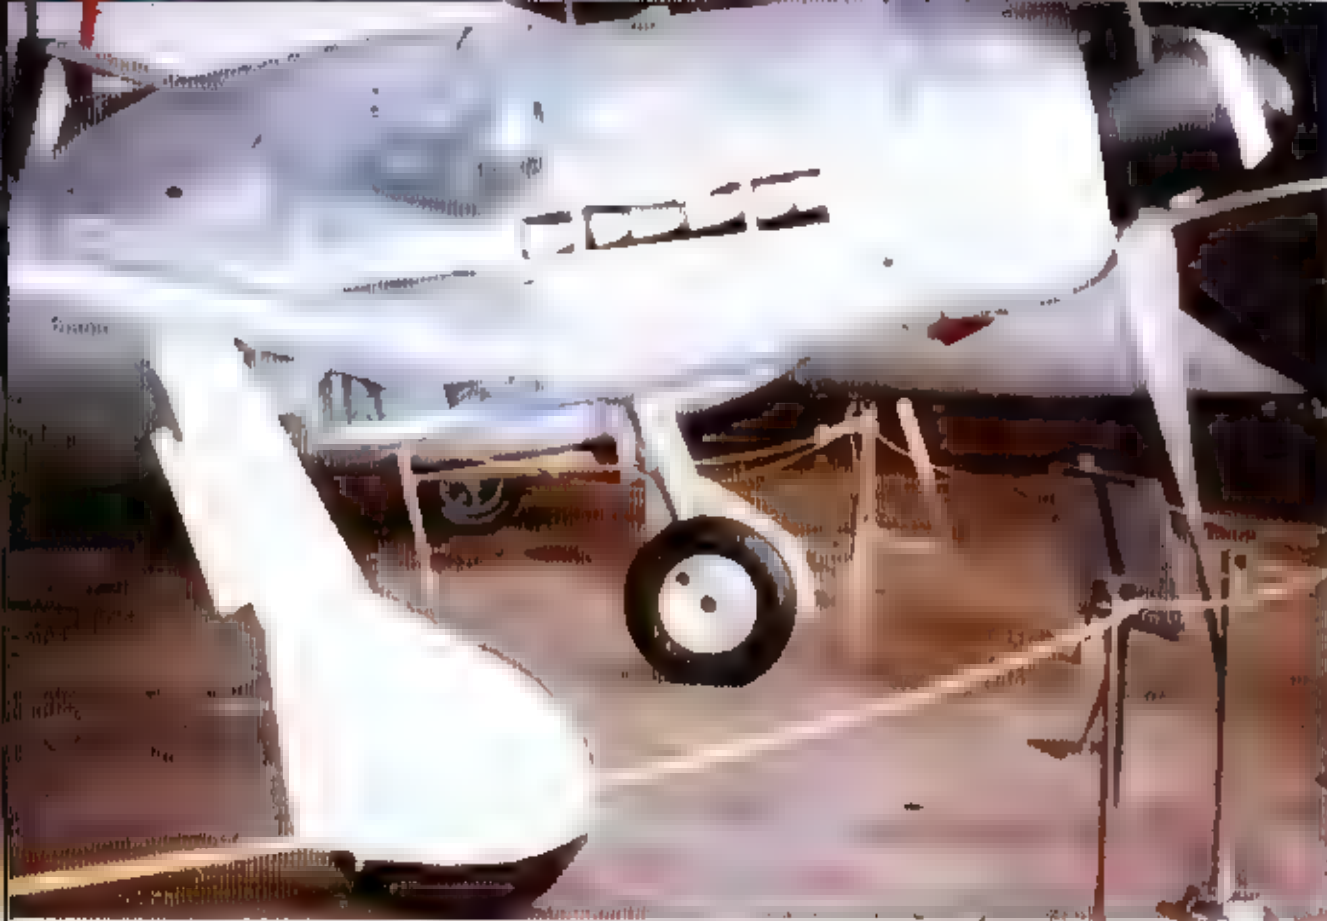
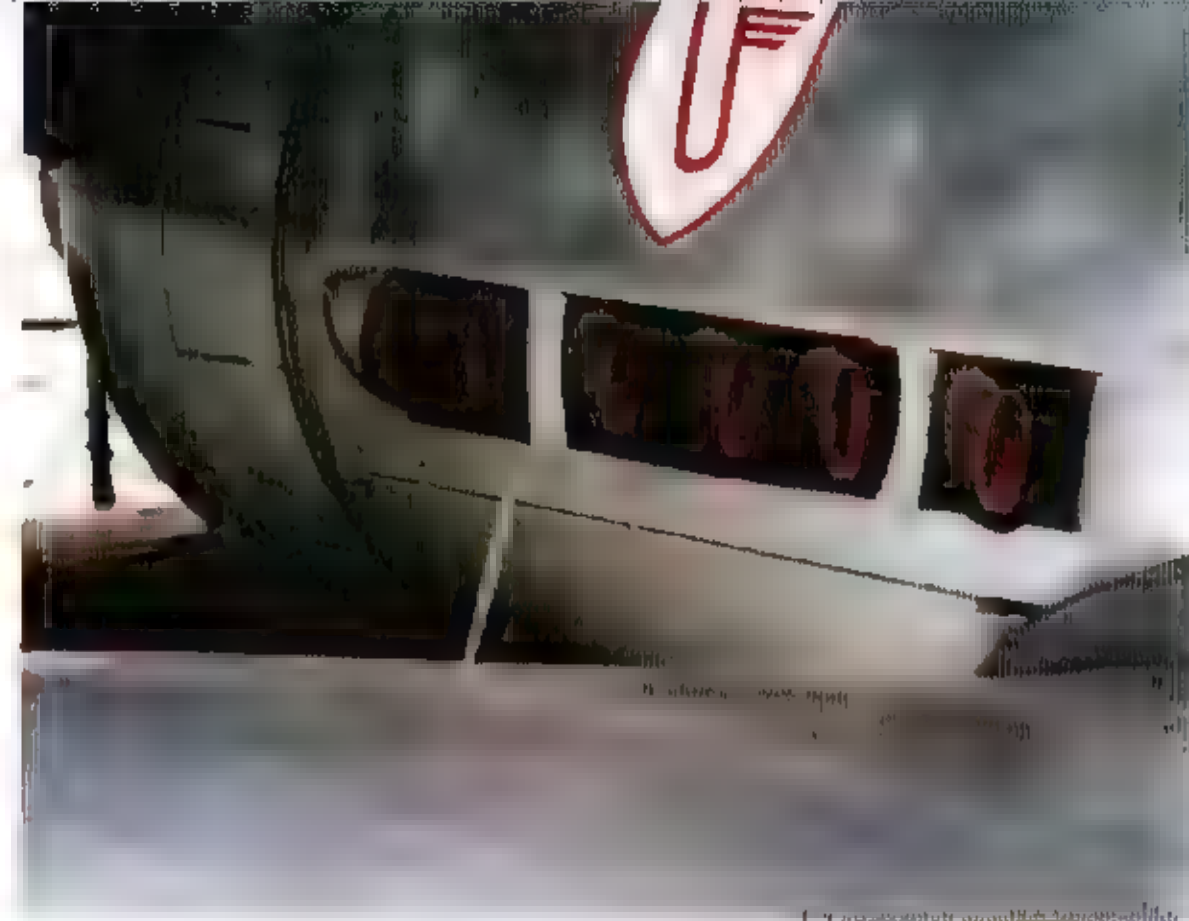
(Above) The oval shaped exhausts pipes have weld lines on both the front and back side of each exhaust. The rod extending upward from the wing top is the visual wheel position indicator rod. The top of the rod is usually painted red over a bottom of white. (J. Bishop)

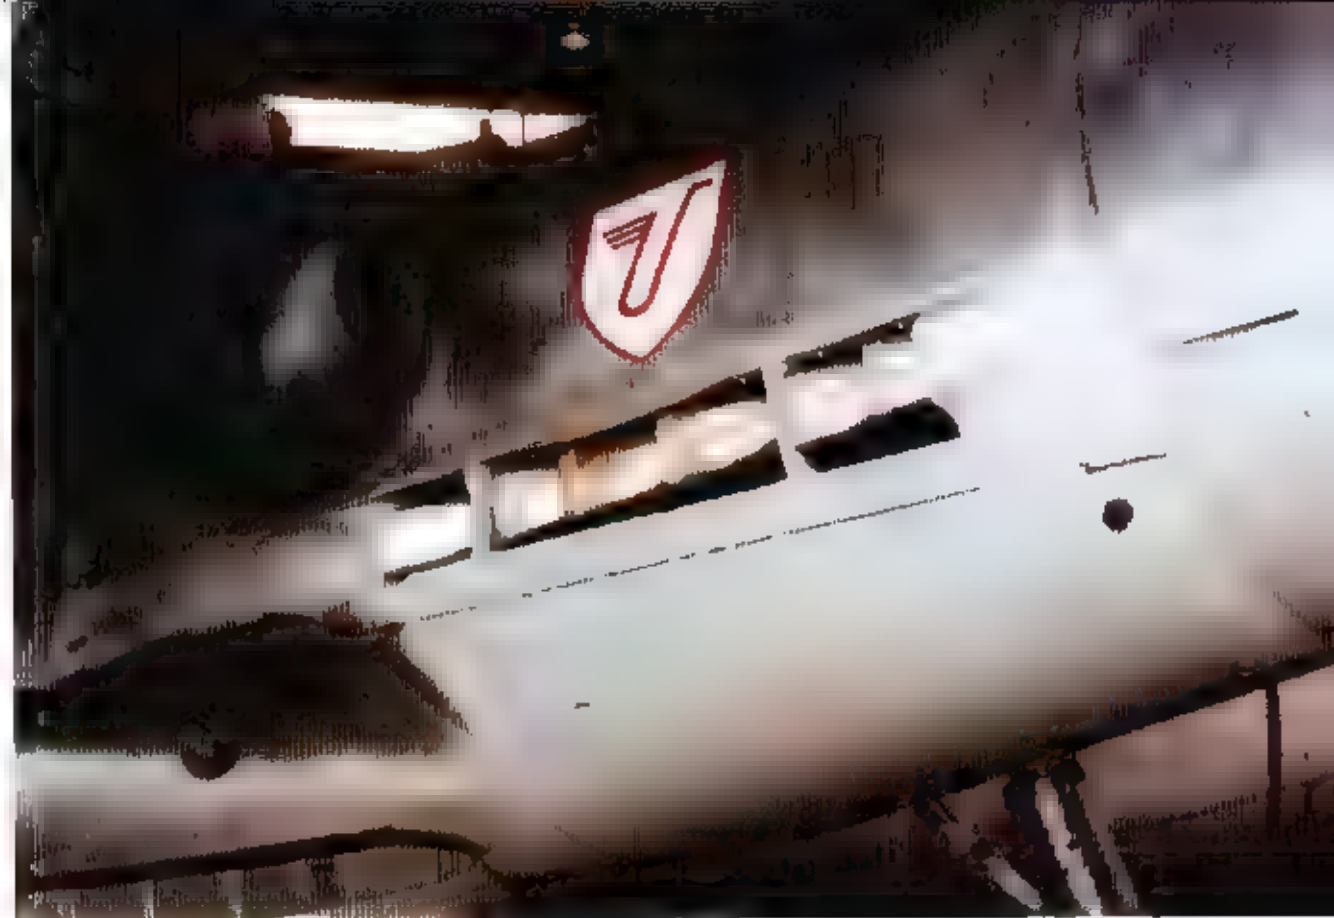
(Above right) The starboard side of the lower engine cowl just behind the cowl flaps is the coolant overflow pipe. The opening around the exhausts is somewhat larger at the front than at its rear. (J.Bishop)

The spinner is a reproduction and the propeller blades are not the VS-111 or VS-9 blades specified for the Fw 190D-9. The circular radiator of the Fw 190D-9 can be seen behind the reproduction spinner. (J. Bishop)

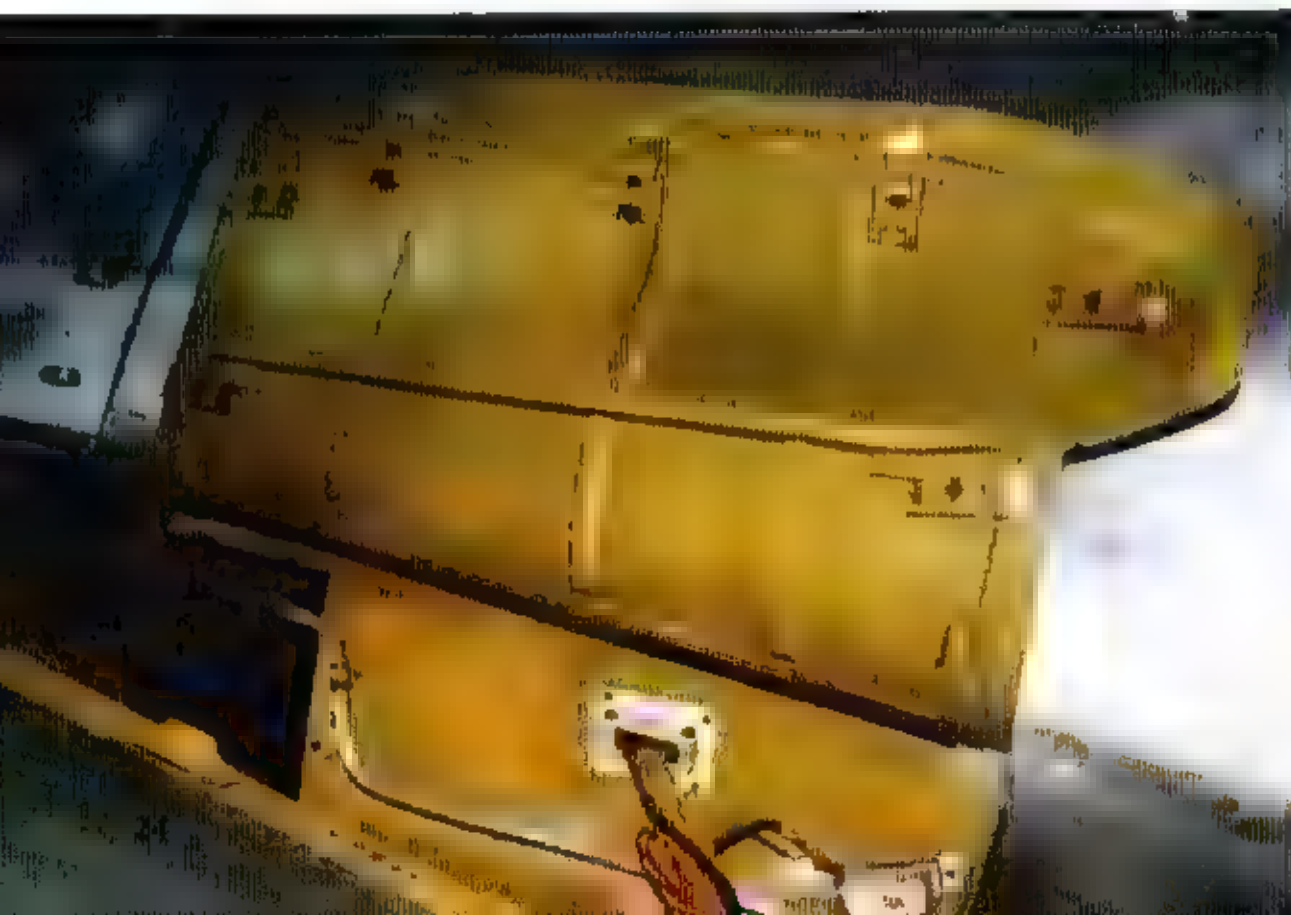
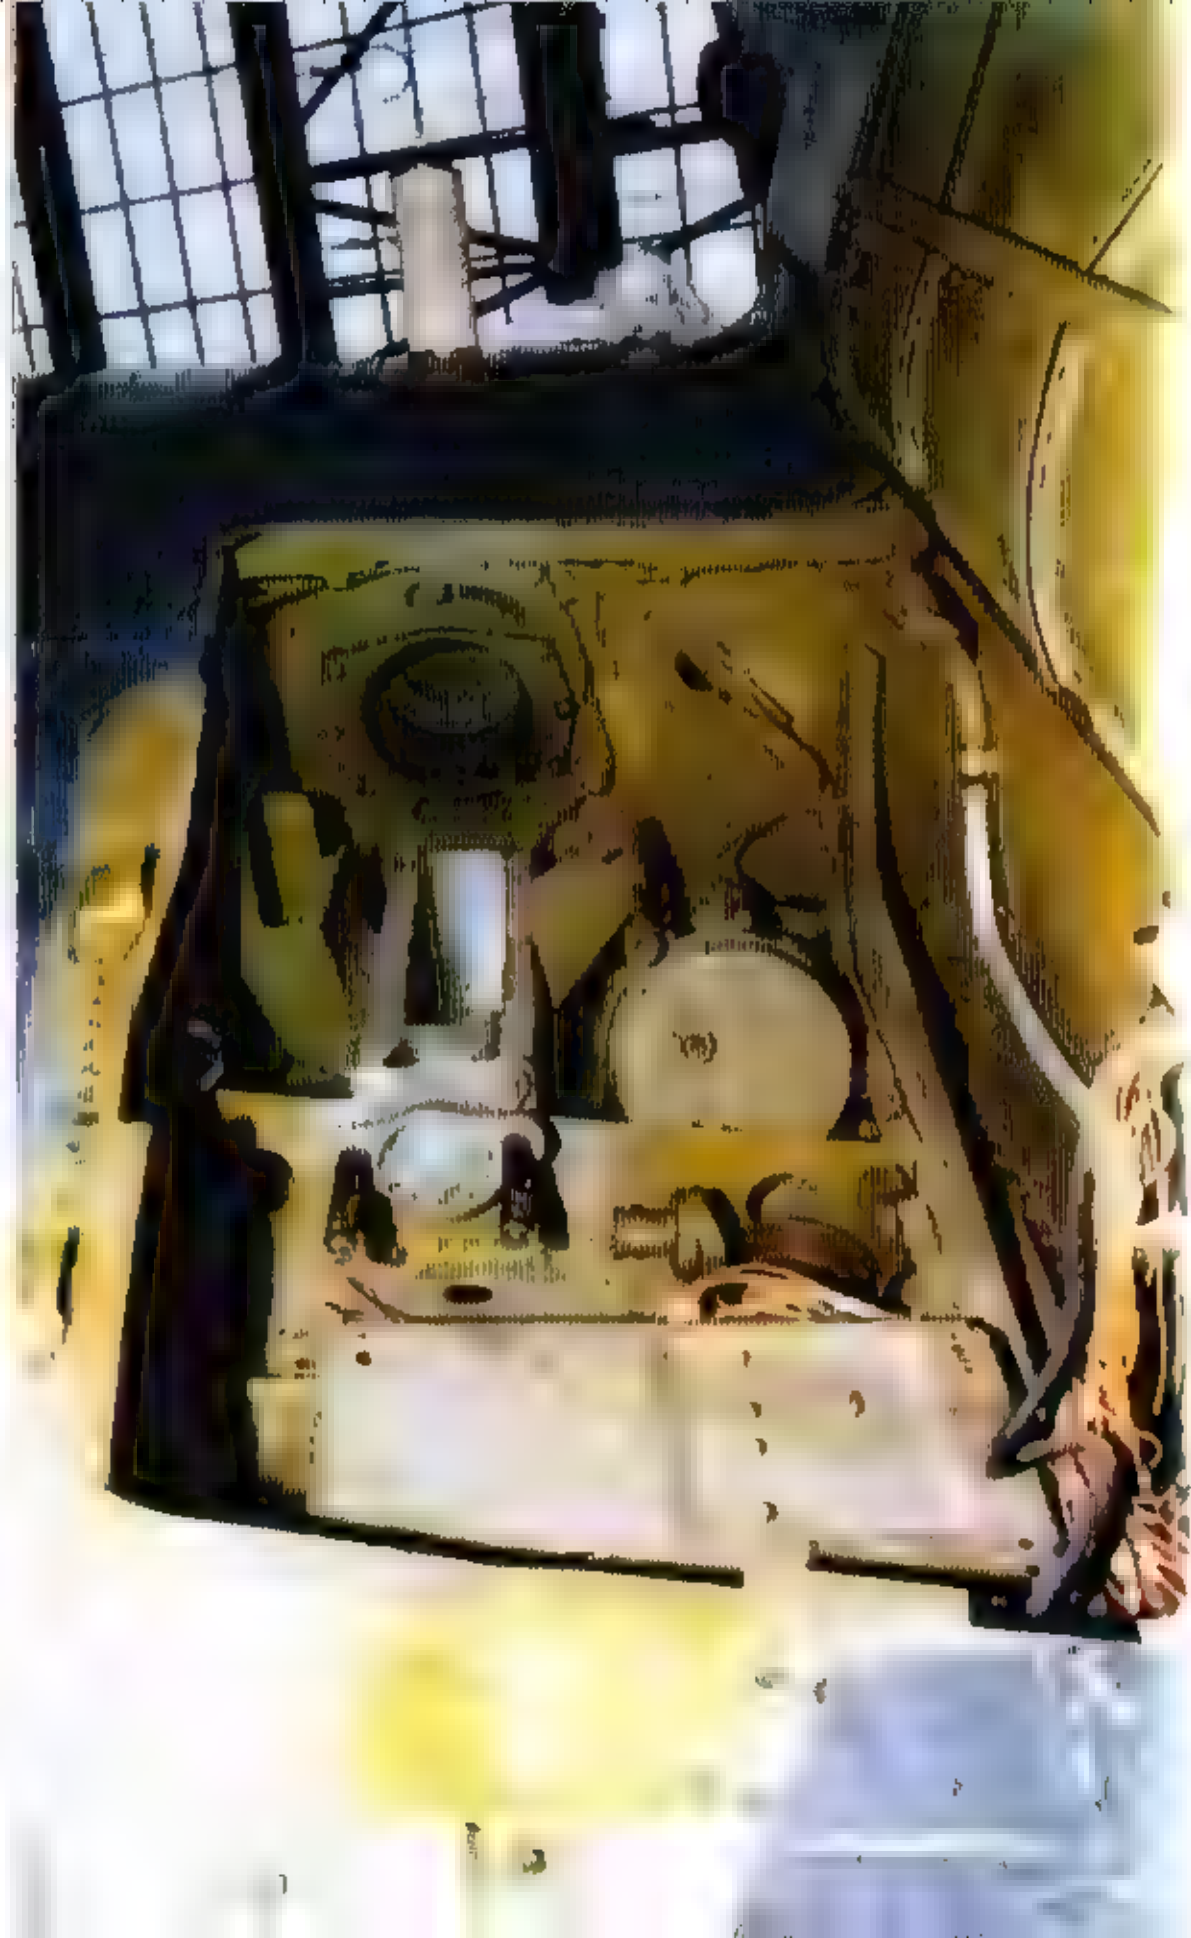
(Above) The port wing root fillet and the 20mm cannon access panel are both bolted to the fuselage with the cannon panel having a hinge just below the bolts. The wear marks on the wing are from museum personnel climbing on and off the aircraft — operational aircraft would have the same wear marks. (Author: Ryle)

(Below and Right) The port wing root cannon access panel in the open position. The 20mm cannon is not installed affording a look at the various items under and around the MG 151. The wiring bundle coming out of the fuselage is part of the electrical system for cocking and firing the cannons. The gap at the front of the gun bay is for the 20mm ammunition and its feed chute. (Author: Ryle)

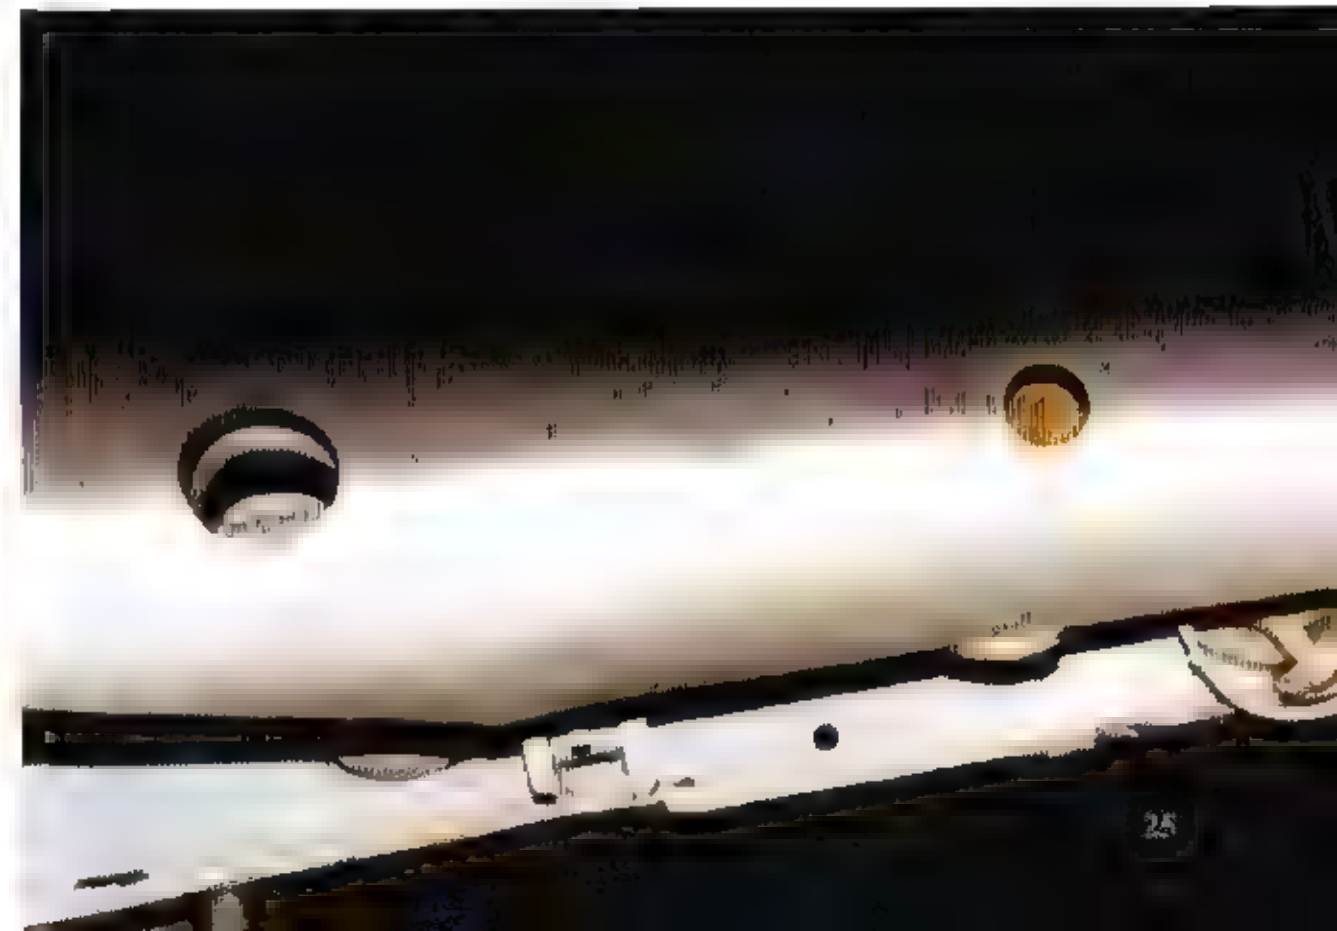
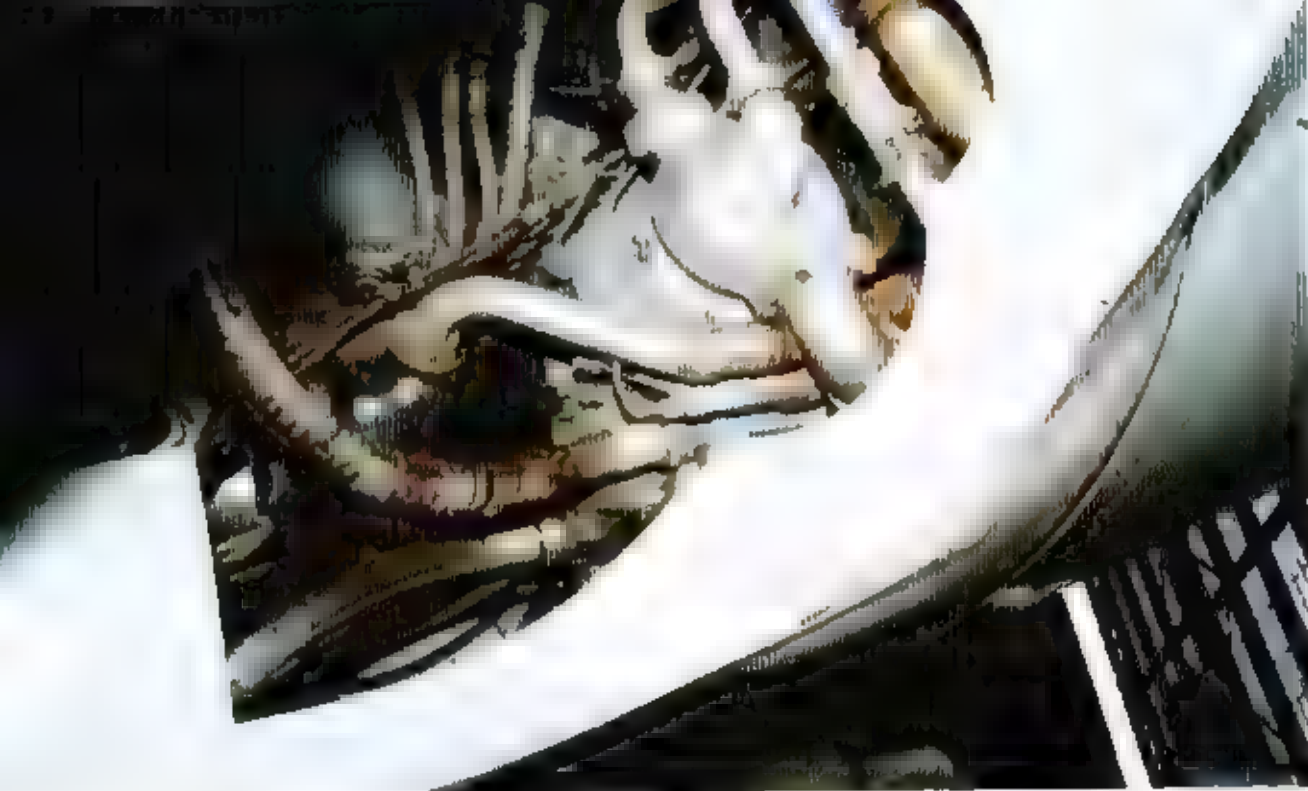
(Above and below) The port wing leading edge showing the empty wing root cannon port and the gun camera port. While the 20mm cannon port was produced as a part of the wing's leading edge panel, the camera port is a separate piece riveted into the leading edge of the wing panel. The glass cover on the camera port (missing) was exchangeable for a colored light filter. (D. Ryle)

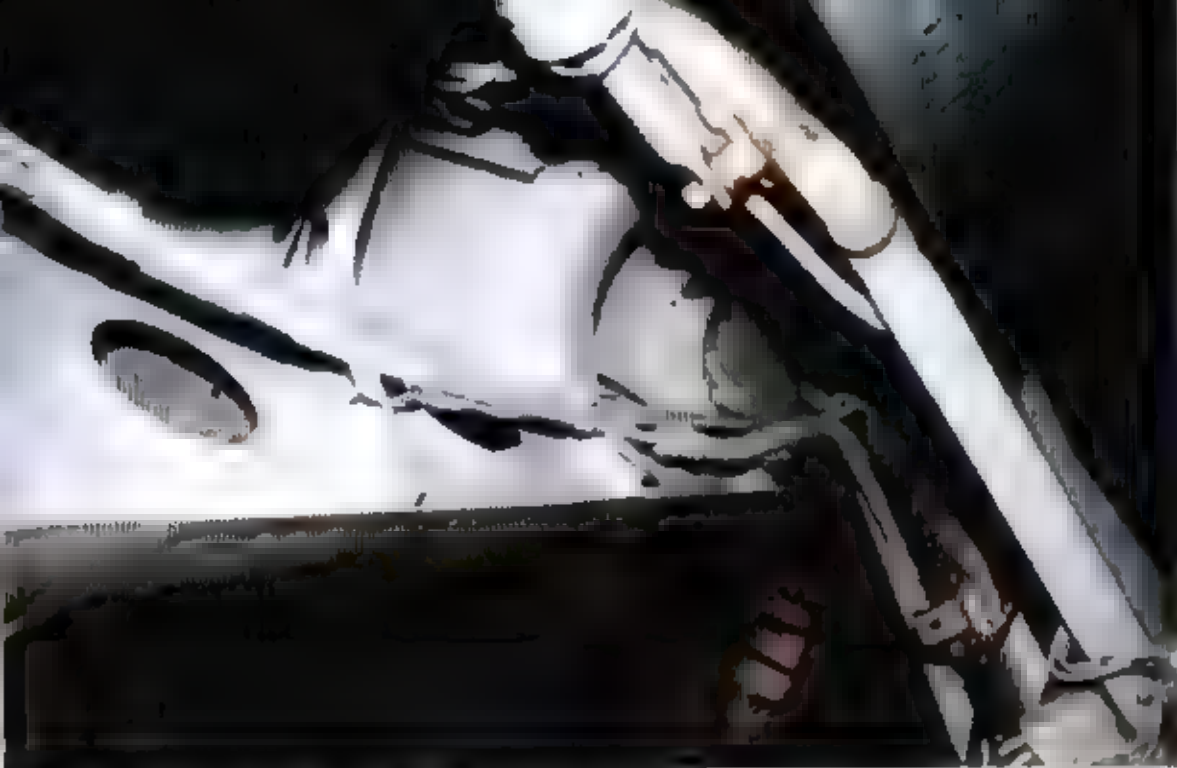
The starboard main wheel well contains a great deal of the lower engine plumbing. (J. Bishop)

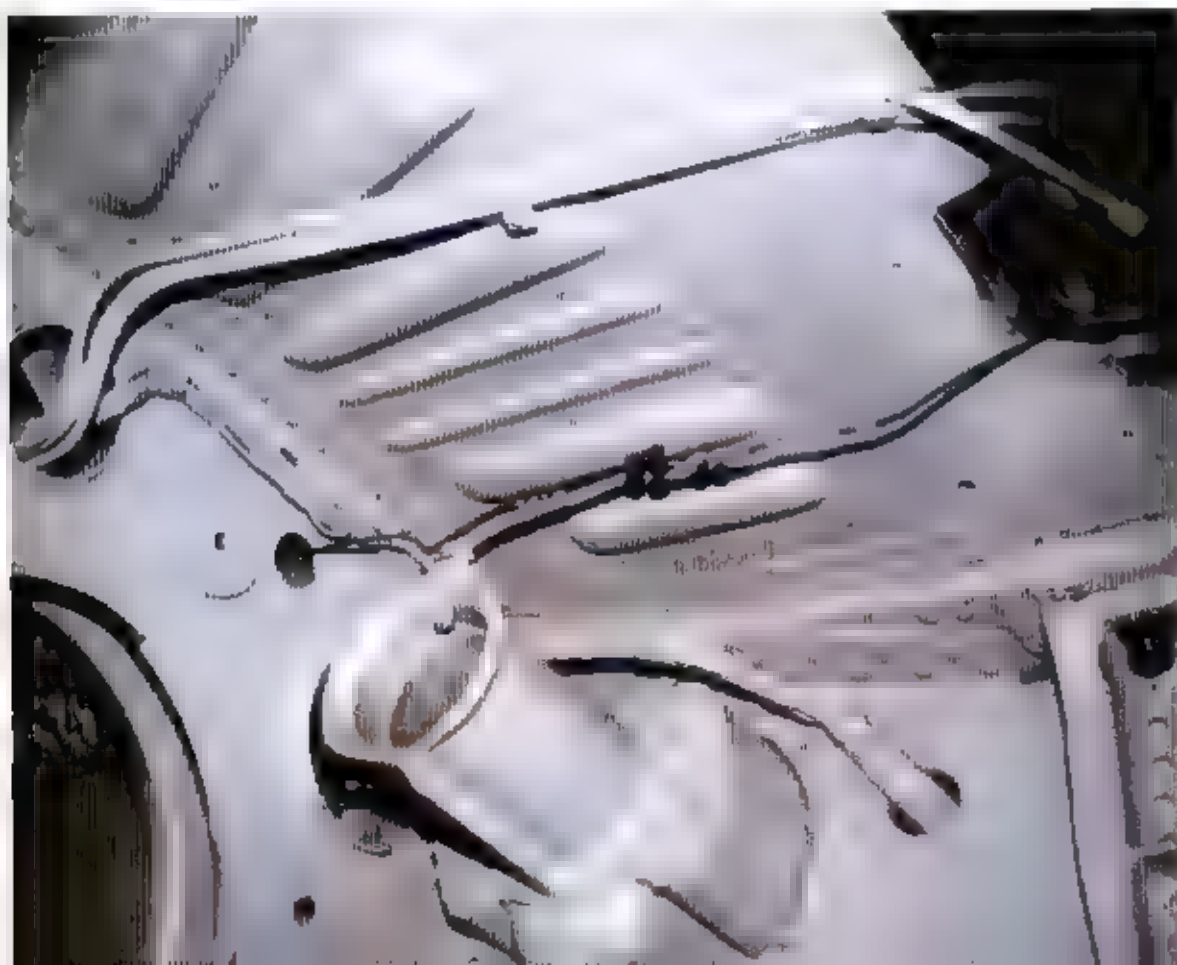
(Above) The construction of the starboard wheel well's forward wall with its electrical and brake lines are seen to advantage. (Author: Ryle)

(Right and below) The 20mm wing root gun mount coming out of the main spar. The pattern on the upper portion of the well are stiffeners stamped into the panel. A landing gear up-lock should be between the two braces outboard of the gun mount, but it is missing. (Author: Ryle)

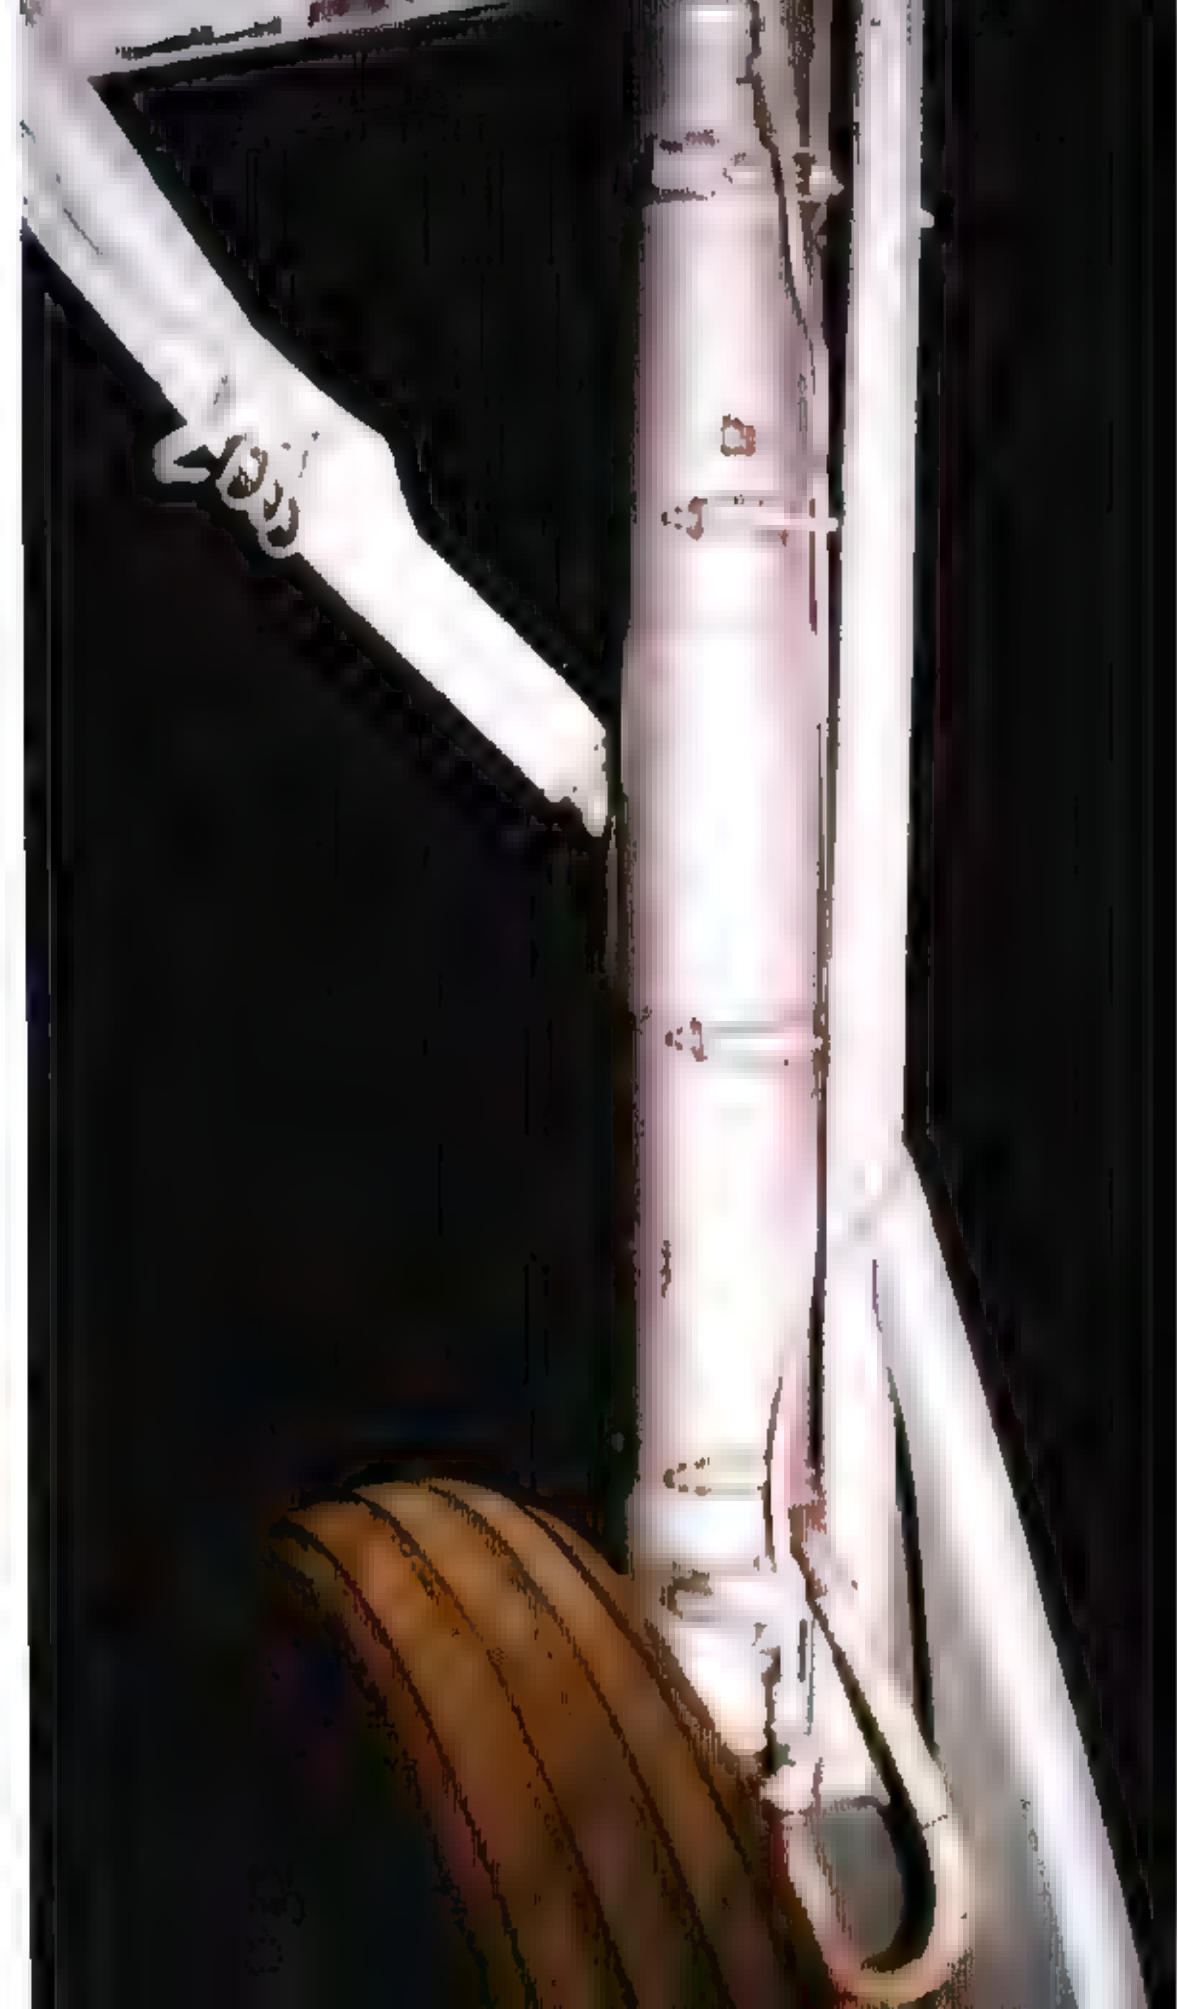
(Right) The forward side of the starboard landing gear. The metal line running down the strut is the brake line, which has been disconnected from the wheel and turned up at the bottom. (Author: Ryle)
